Naval Surface Warfare Center Carderock Division

NSWCCARDIV-TR-96/002 March 1996

Survivability, Structures, and Materials Directorate Technical Report

Moisture Diffusion in Impact Damaged Face Sheets of Composite Sandwich Materials

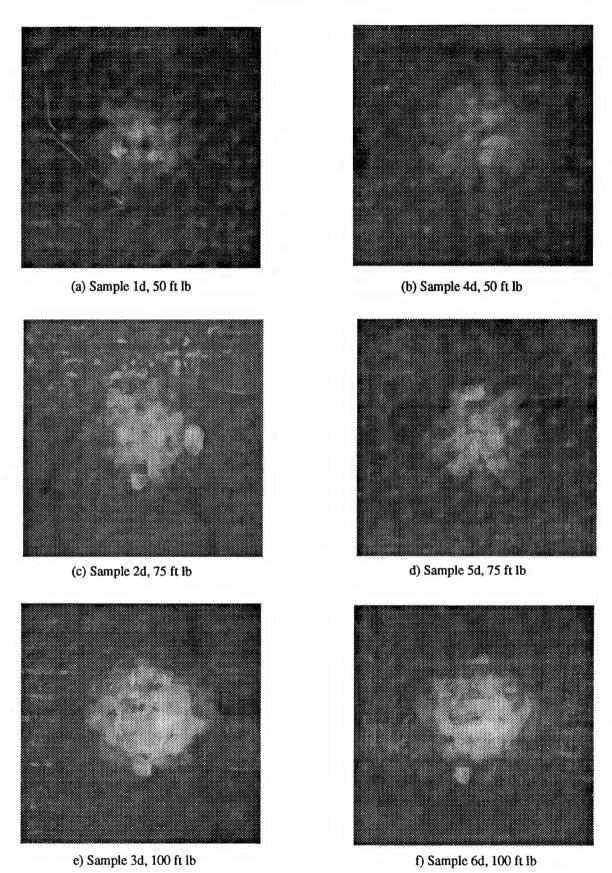
Although the samples impacted with 50 foot-pounds (see Figure 1) appear to have only a small damage, the resulting diffusion coefficient of the damaged area, however, is almost hundred times larger than the diffusion coefficient measured on samples whithout the damaged area. The average diffusion coefficient measured from all undamaged specimens is 4.10E-9 cm²/sec, while that of the 50 foot-pounds impacted samples is 3.27E-7 cm²/sec. The average maximum equilibrium moisture solubility of all undamaged samples is 0.1716 g/100g. The average of all

We found that a significant increase in the diffusion coefficient of impacted areas where the damage is hardly noticeable. A low level impact (50 foot-pounds) caused only a small spot of discoloration (caused by micro-cracks) in the green colored vinyl/E-glass composite face sheet. However, the resulting change in diffusion coefficient between the damaged and undamaged area was about 100 to 1.

Figure 1. Impacted Speciments, Front Side

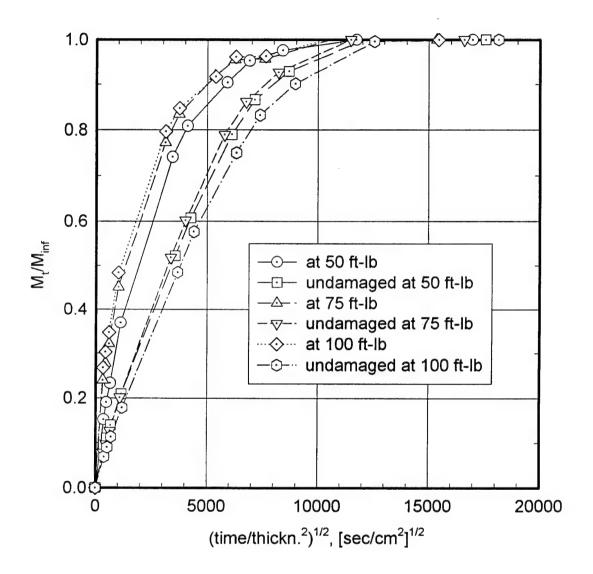
Figure 7 shows the curves of M_t/M_{∞} versus (time/thickness²)^{1/2} for the first three damaged panels, 1d through 3d. Figure 8 shows the same curves for the second set of damaged panels, 4d through 6d. The individual data points are listed in the appendix.

Figure 7. Sorption Isotherm of RTM3 Sandwich Panel Face Sheets (No. 1d through 3d) with Damaged and Undamaged Specimens.

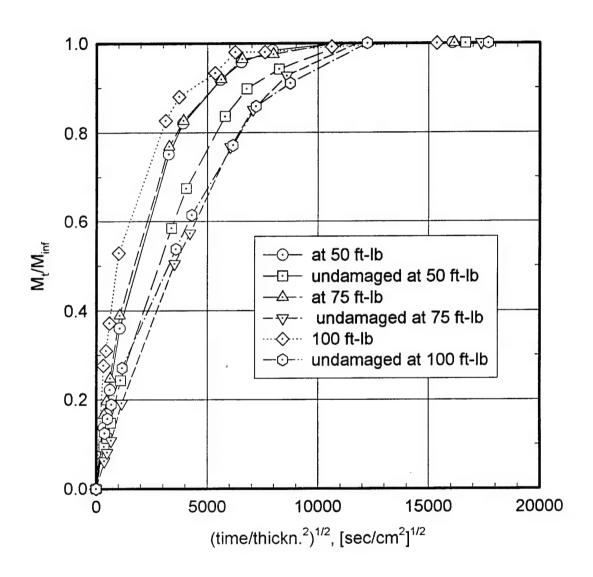
Figure 8. Sorption Isotherm of RTM3 Sandwich Panel Face Sheets (No. 4d through 6d) with Damaged and Undamaged Specimens.

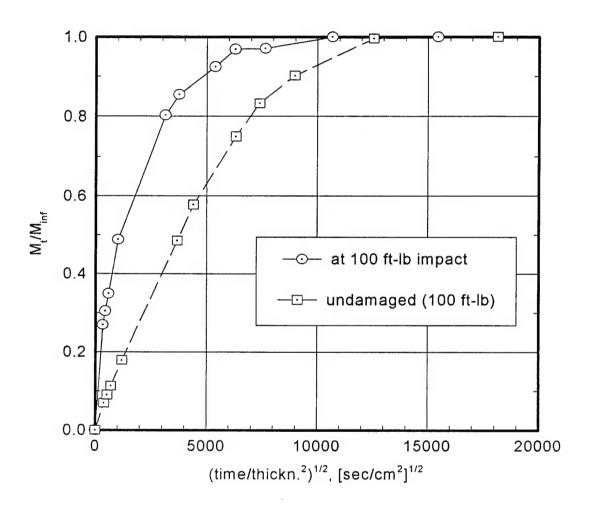
We will demonstrate with one example how the experimental data were used to determine the diffusion coefficient of the damaged specimens (using method C described in the last section). Figure 9 shows the sorption curves of the damaged and undamaged specimens from panel No. 3d which has been impacted with 100 foot-pounds. For a better estimate, we have expanded the time axis (of Figure 9) giving Figure 10. Using the nomenclature of the last section, we find that the intersection of S_1 and S_2 (indicated by dashed lines) is projected parallel to the M_r/M_∞ -axis up to the value 1.0, giving a value of 520 on the (time/thickness²)^{1/2}-axis. The straight line from the origin to that point is the slope S_d (with a value of 0.001923) from which the diffusion coefficient of the damaged area is calculated [using Equation (2)] resulting in a value of 7.34E-07 cm²/sec. The other sorption curves of the impacted specimens were evaluated the same way. The respective diffusion coefficients of the undamaged face sheet specimens were calculated in the usual way from the slope S_u of the sorption curves.

Figure 9. Sorption Isotherm of RTM3 Sandwich Panel Face Sheets (No. 3d) Impacted with 100 ft-lb, Damaged and Undamaged Specimen.

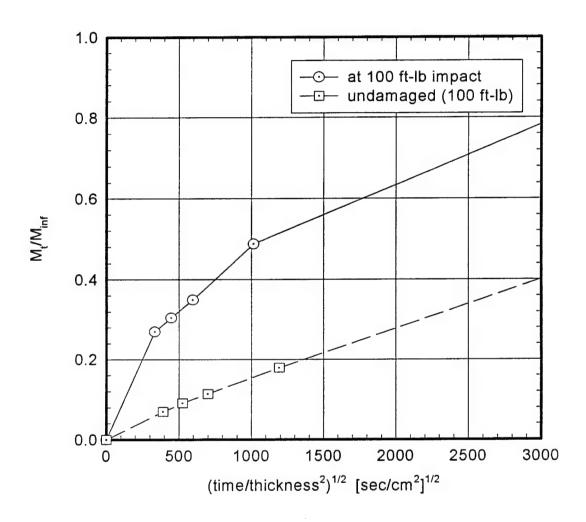
Figure 10. Magnified Initial Moisture Sorption (in Damaged and Undamaged RTM3 Face Sheet of Panel No. 3d) for a Graphical Determination of the Diffusion Coeff. for the Damaged Area.

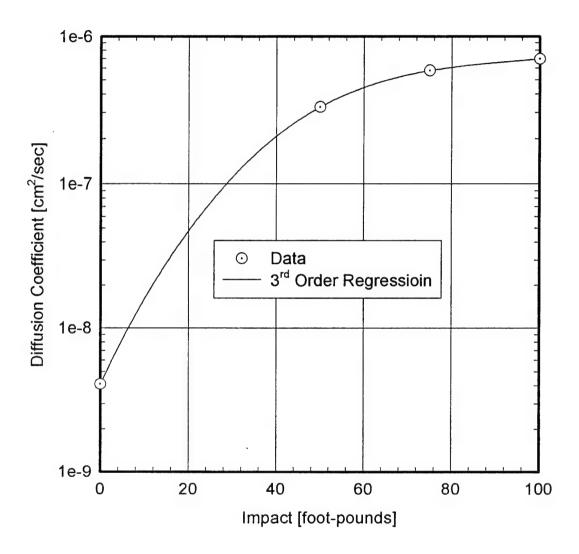
Figure 11 shows the change in moisture diffusion coefficient of the damaged area in a 0.1-inch thick RTM3 vinyl/E-glass face sheet of 1.0 inch thick balsa wood sandwich panels after they had been impacted.

Figure 11. Change of the Moisture Diffusion Coefficient in a Vinyl RTM3/E-Glass Composite Face Sheet as a Function of Impact Level.
